(9) Special Report 77-40
(19) SR-77-40

WINTER EARTHWORK CONSTRUCTION IN UPPER MICHIGAN.

(10) W.M./Haas, B.D./Alkire
and J.E./Dingeldein

Prepared for
DIRECTORATE OF MILITARY CONSTRUCTION
OFFICE, CHIEF OF ENGINEERS

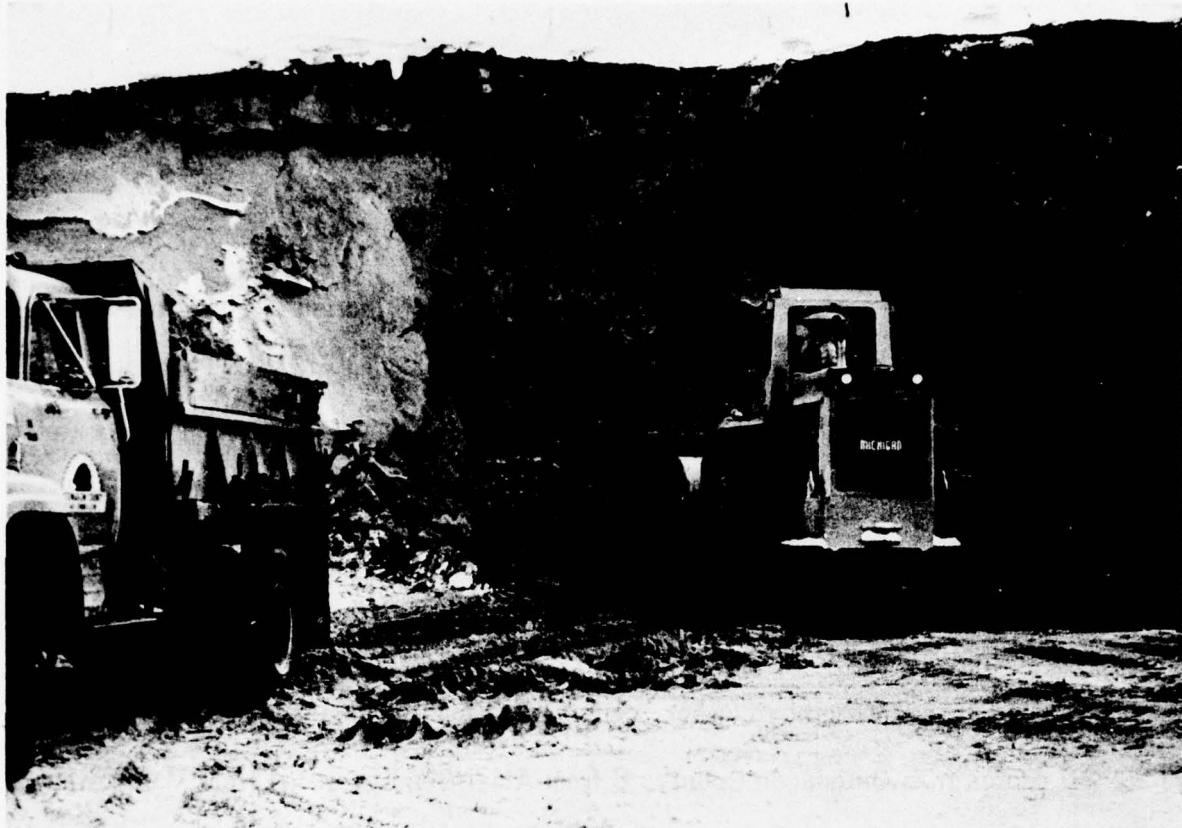
1. Ontonagon County. Loader working in Simar pit. Note height of working face, and type of dump truck used for hauling.

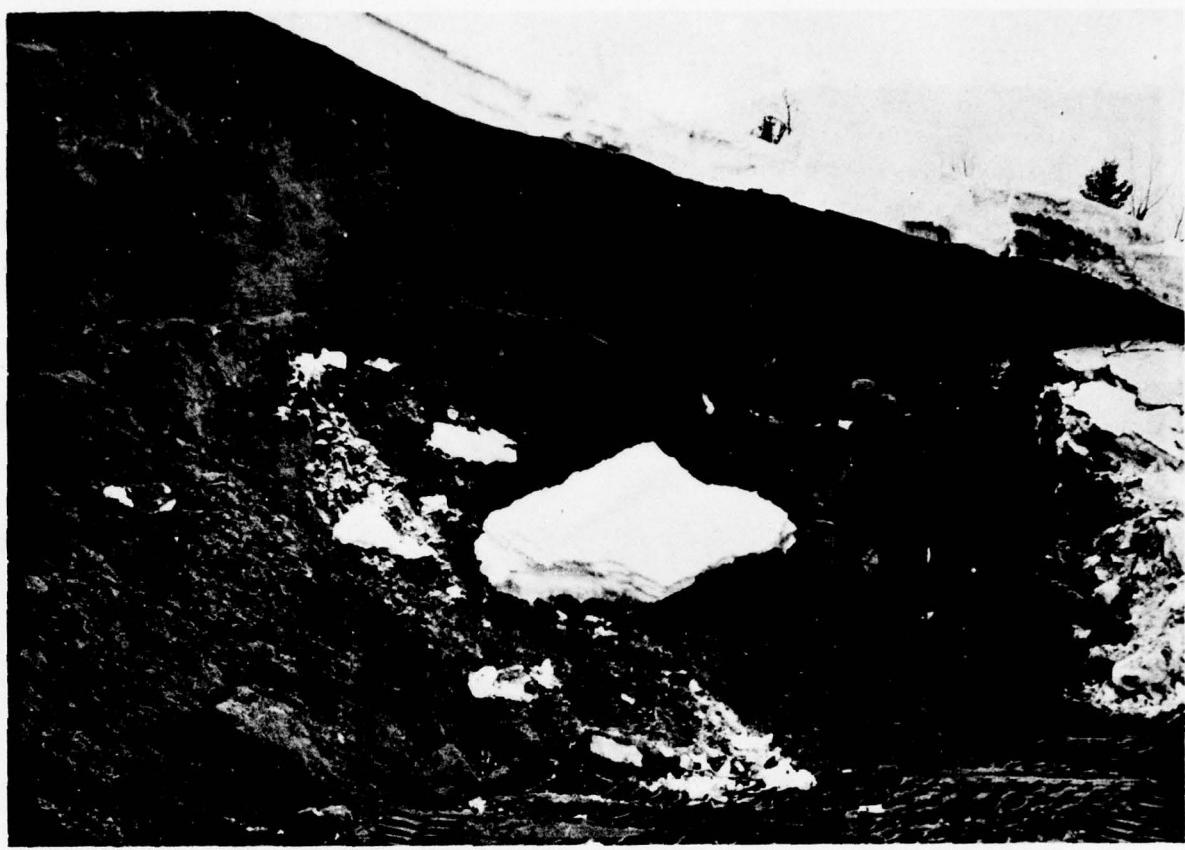
2. Ontonagon County. Simar Pit. Slab of snow-covered frozen soil has fallen into pit.

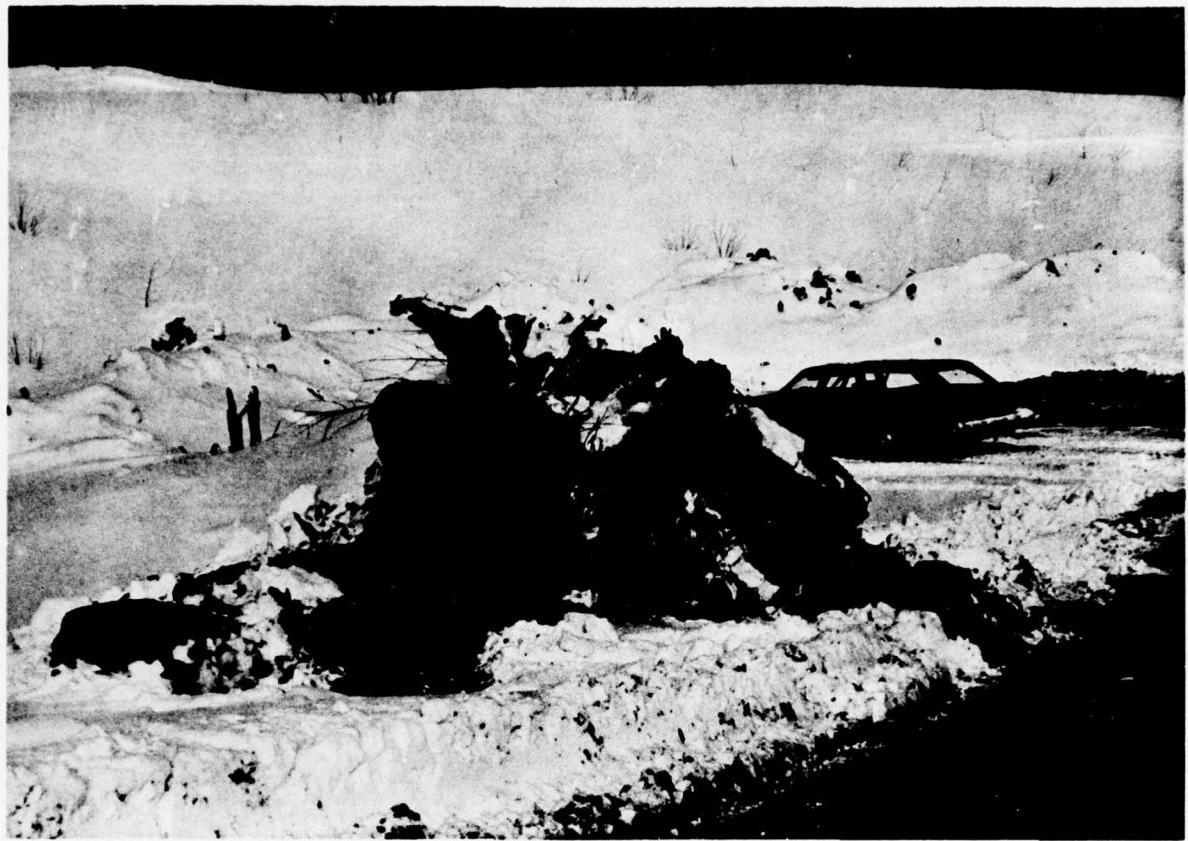
4. Ontonagon County. Simar Pit. Pile of frozen soil which was removed from the loading area.

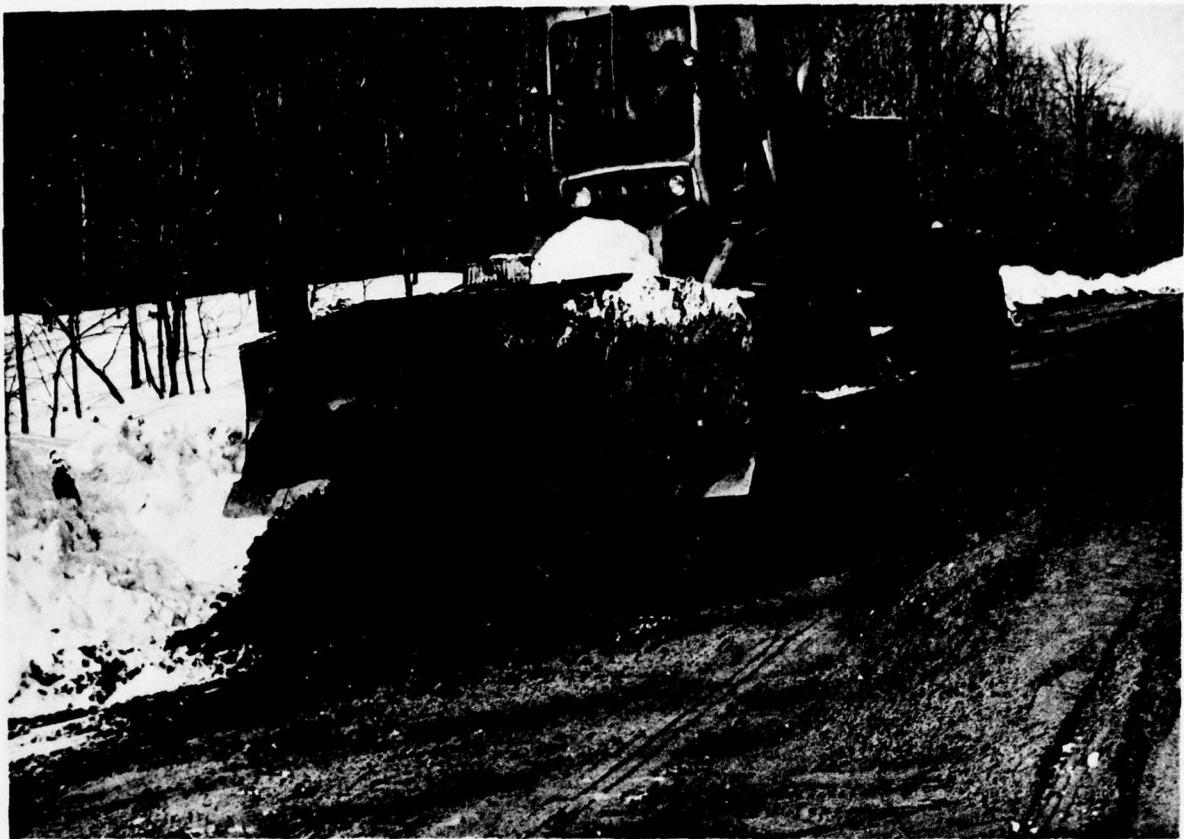
6. Ontonagon County. North Firesteel Road. Another view of spreading and compaction of fill.

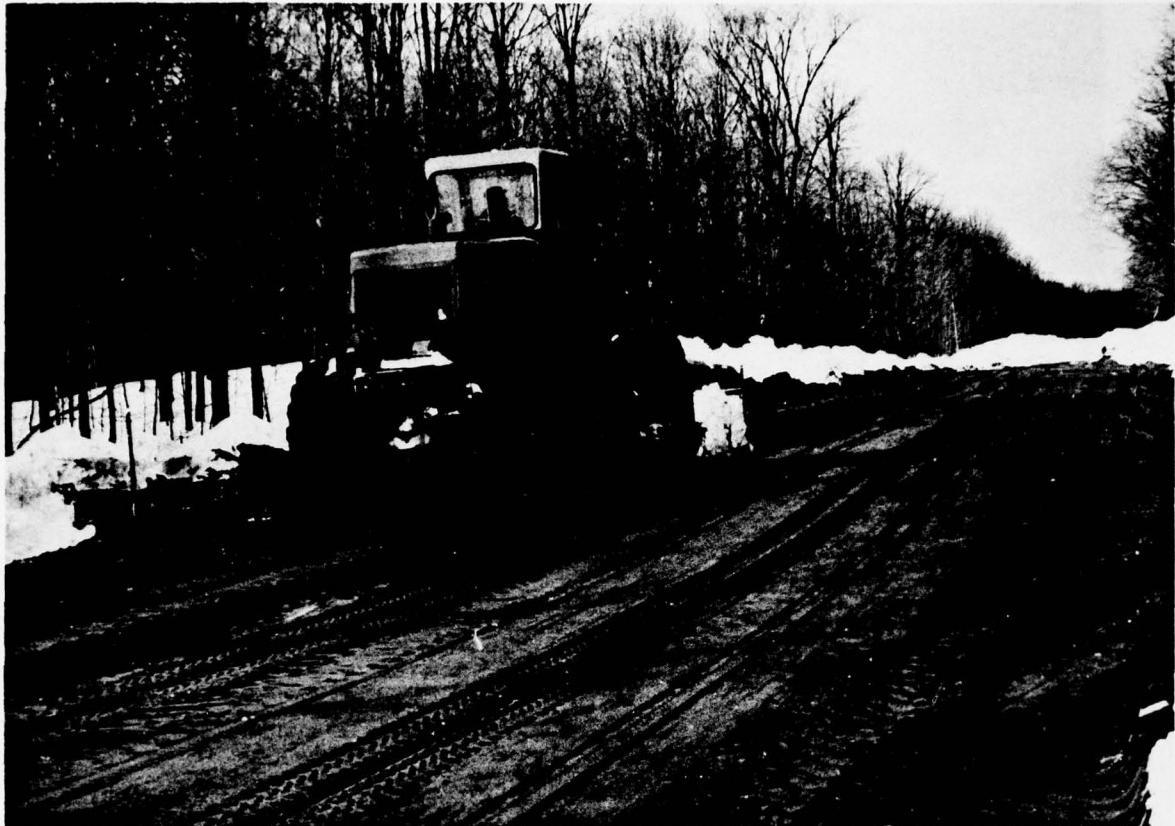
7. Ontonagon County. North Firesteel Road. Back blading and final compaction at end of the working day. Low overnight temperatures freeze fill, creating stable roadway by the next morning.

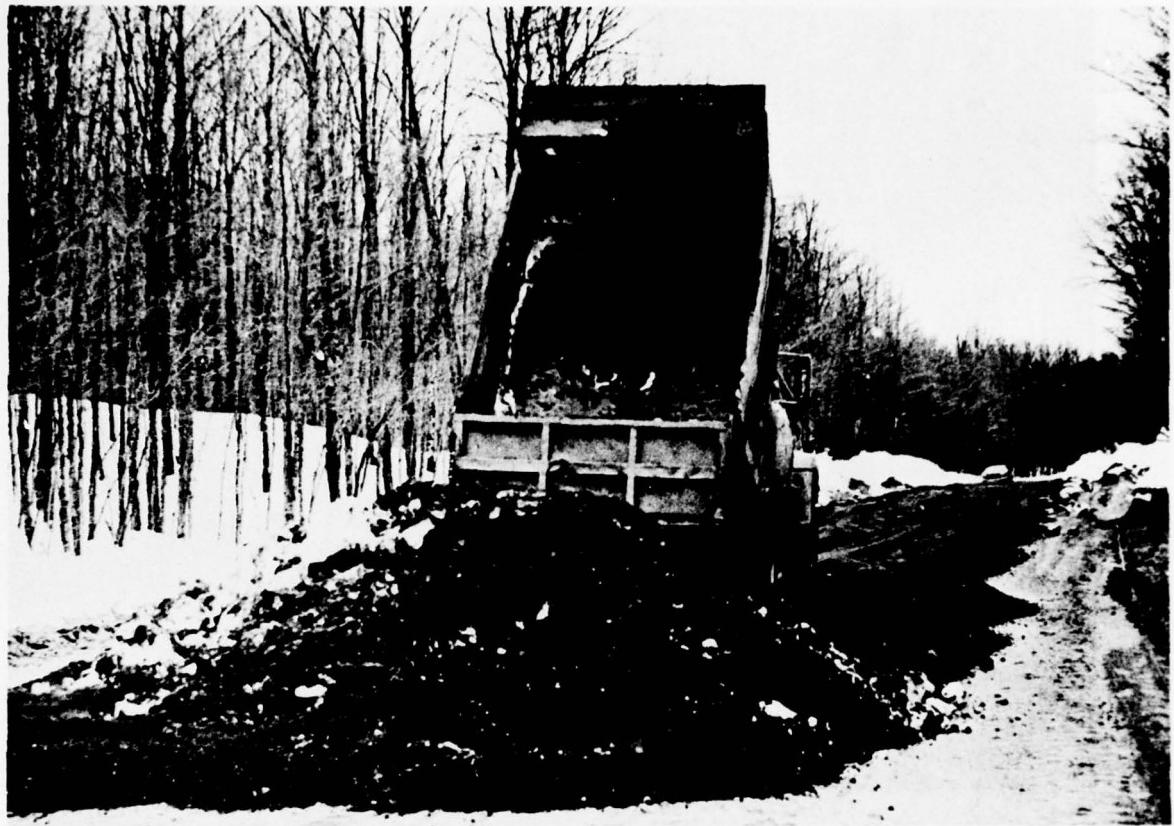
8. Ontonagon County. North Firesteel Road. Sand fill will not bear traffic upon thawing, so gravel surfacing is placed before thawing begins. Gravel is hauled from stockpiles built up the previous summer. Note that considerable snow is included with the gravel.

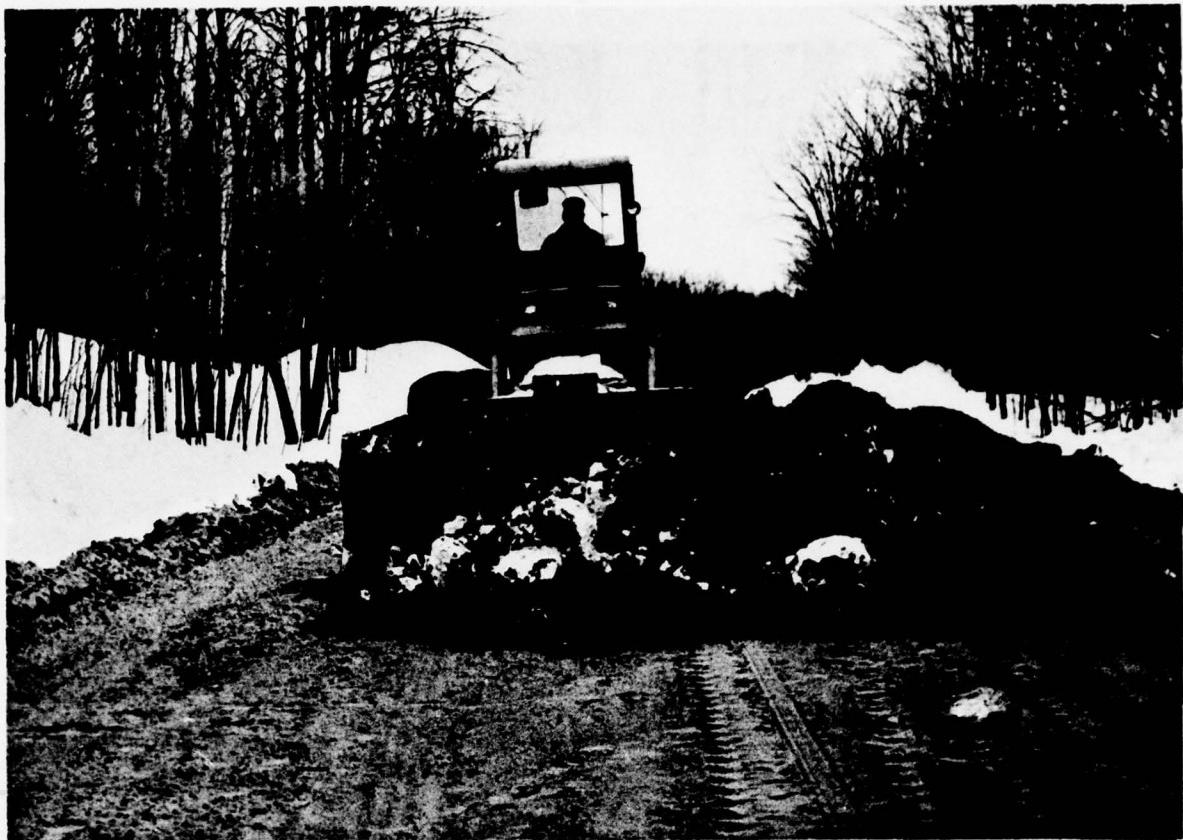
9. Ontonagon County. North Firesteel Road. Spreading and compaction of gravel with rubber-tired dozer.

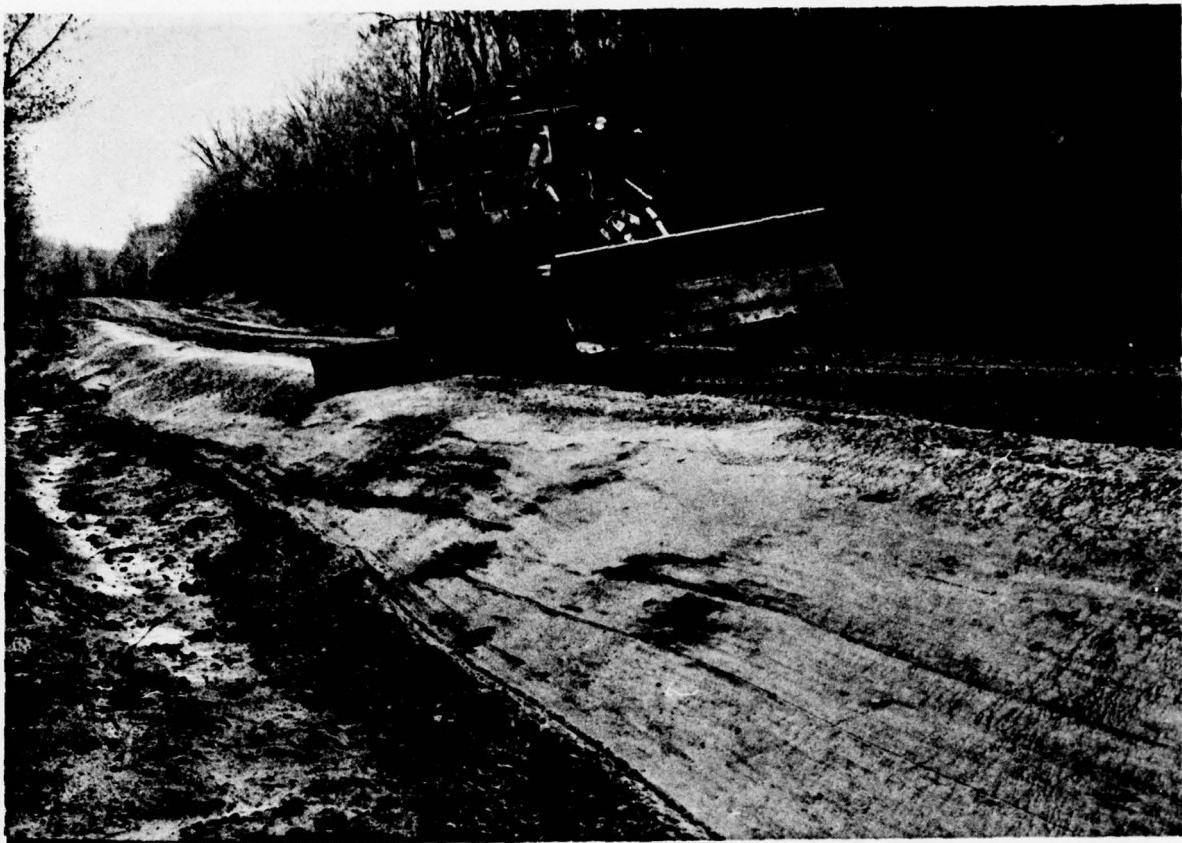
11. Ontonagon County. North Firesteel Road. Second grader in slope finishing team shapes shoulder of sand fill without disturbing gravel. The blade of this grader is specifically adapted to this purpose.

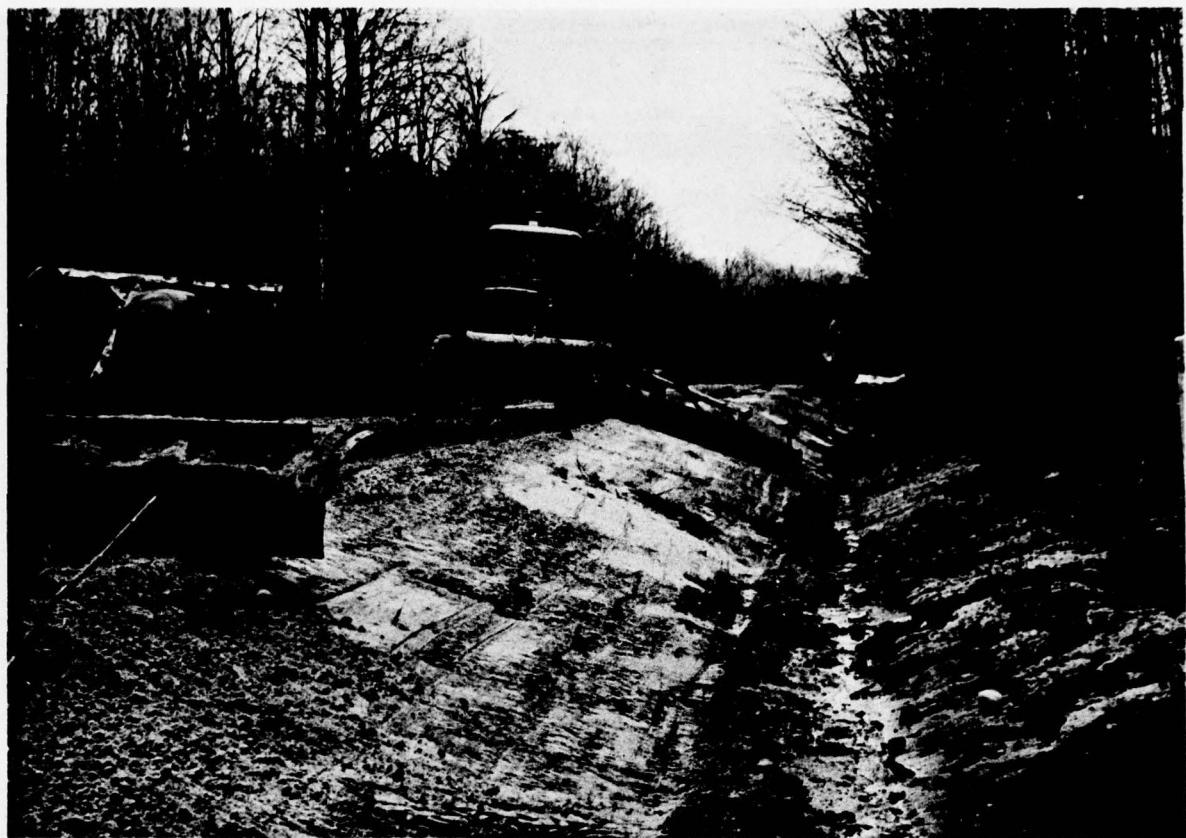
12. Ontonagon County. North Firesteel Road. Another view of slope finishing grader team. Shaping is considered complete after two passes of team.

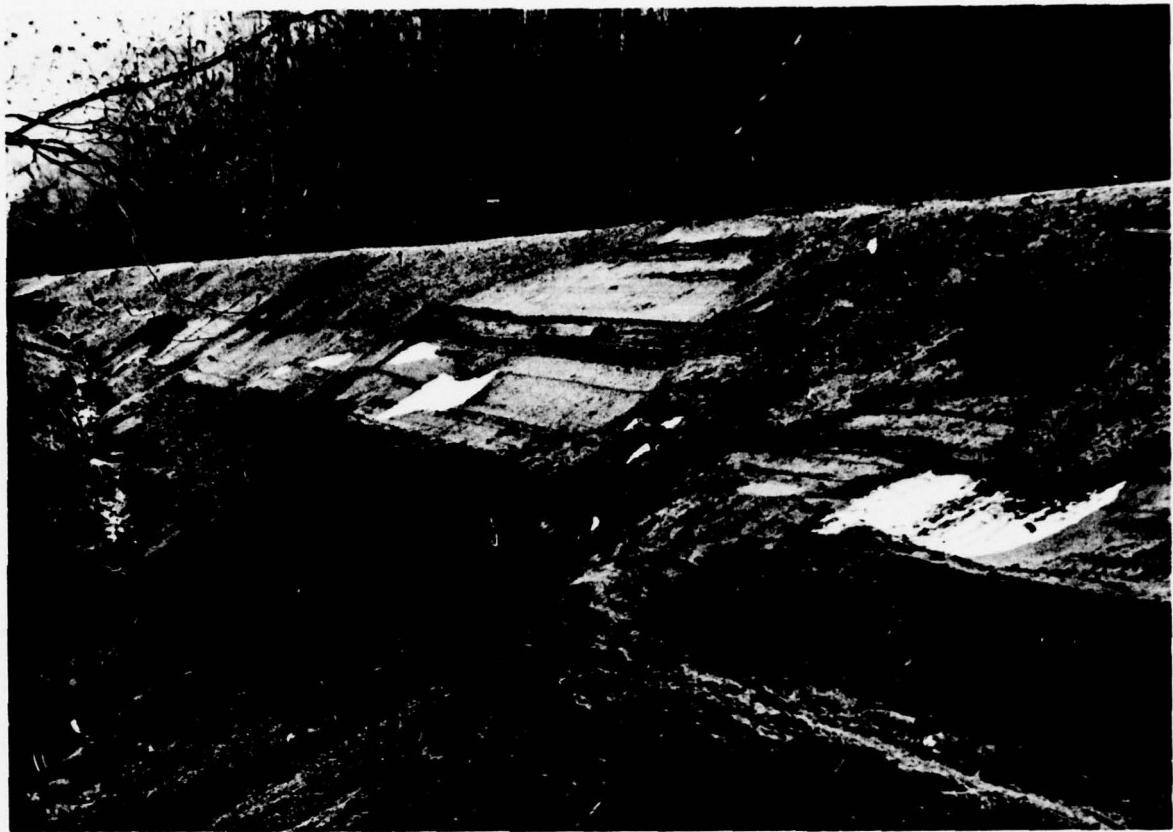
14. Ontonagon County. North Firesteel Road. Evidence that chunks of snow were inadvertently incorporated into slope of fill. Photo taken after slope finishing operation.

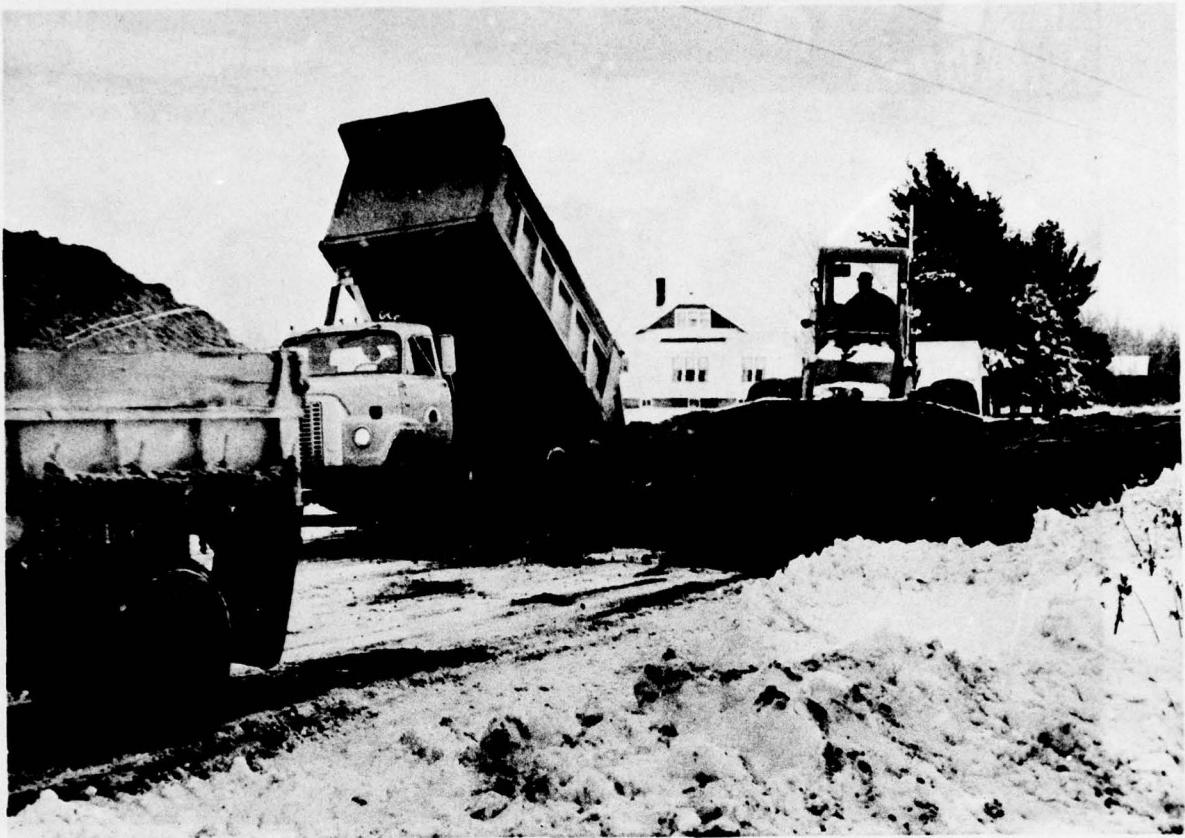
17. Ontonagon County. Wagner Road. General view of hauling, dumping, spreading and compacting.

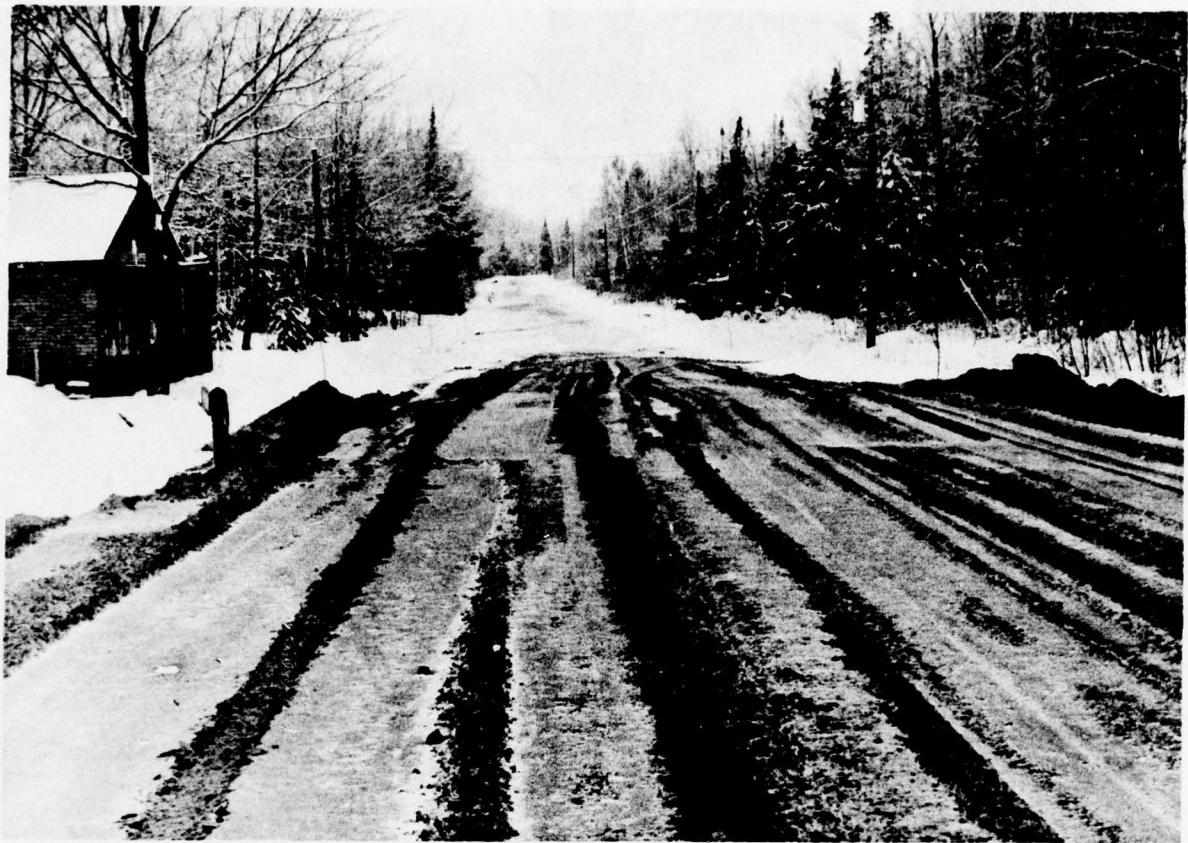
19. Ontonagon County. Cherry Lane. Typical ramp constructed at end of each day's operation. Compacted sand freezes quickly enough that cars and small trucks have little difficulty travelling on fresh grade.

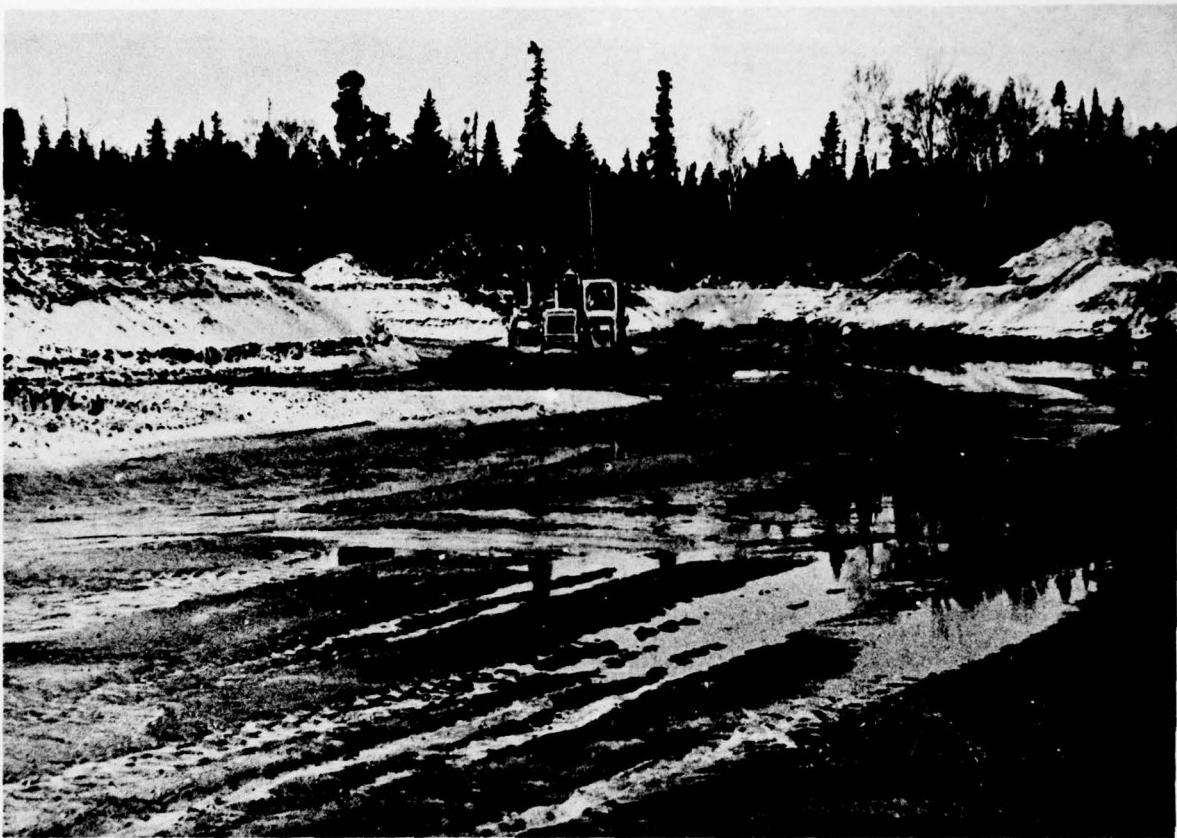
21. Alger County. State Road 28. Although this photo was taken in June 1976, it illustrates the problem of a high ground-water table in the borrow pit which was one of the factors limiting the continuation of earthwork construction through the winter on this project.

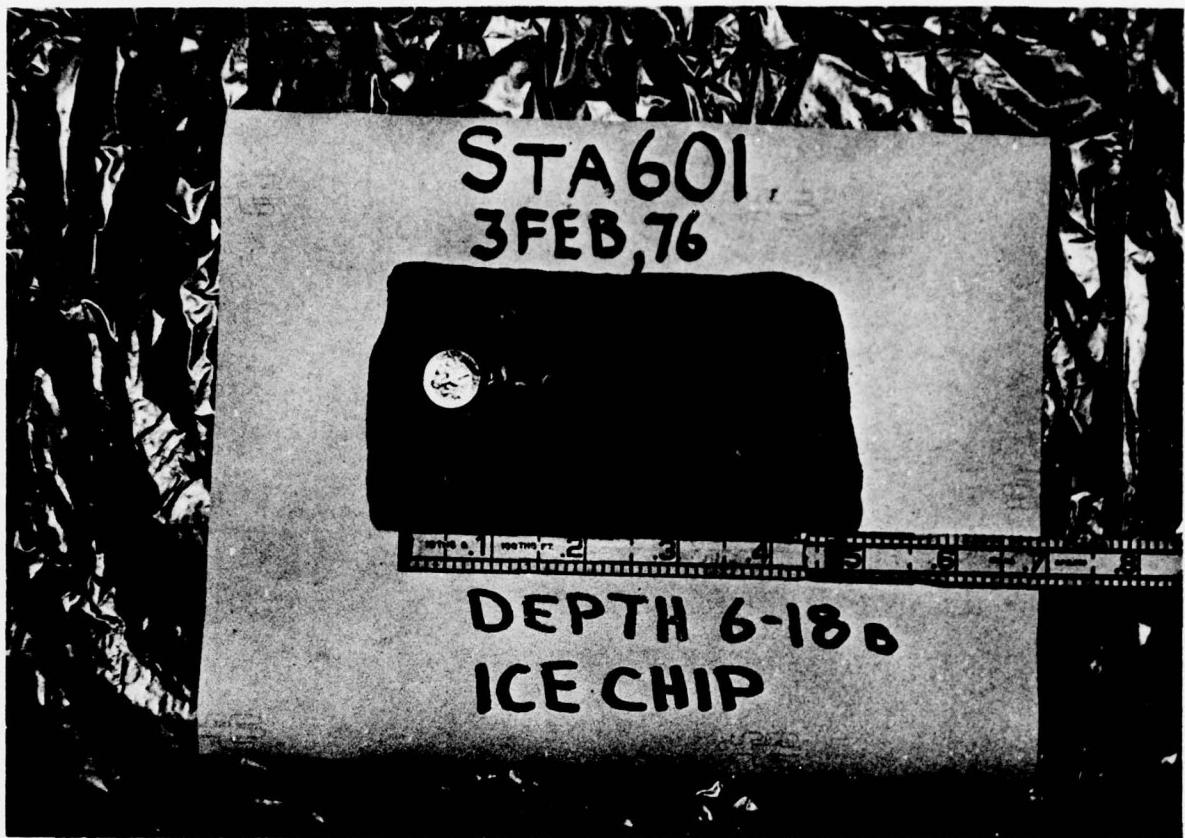
23. Alger County. State Road 28. Close-up of core showing ice chip incorporated into compacted soil.

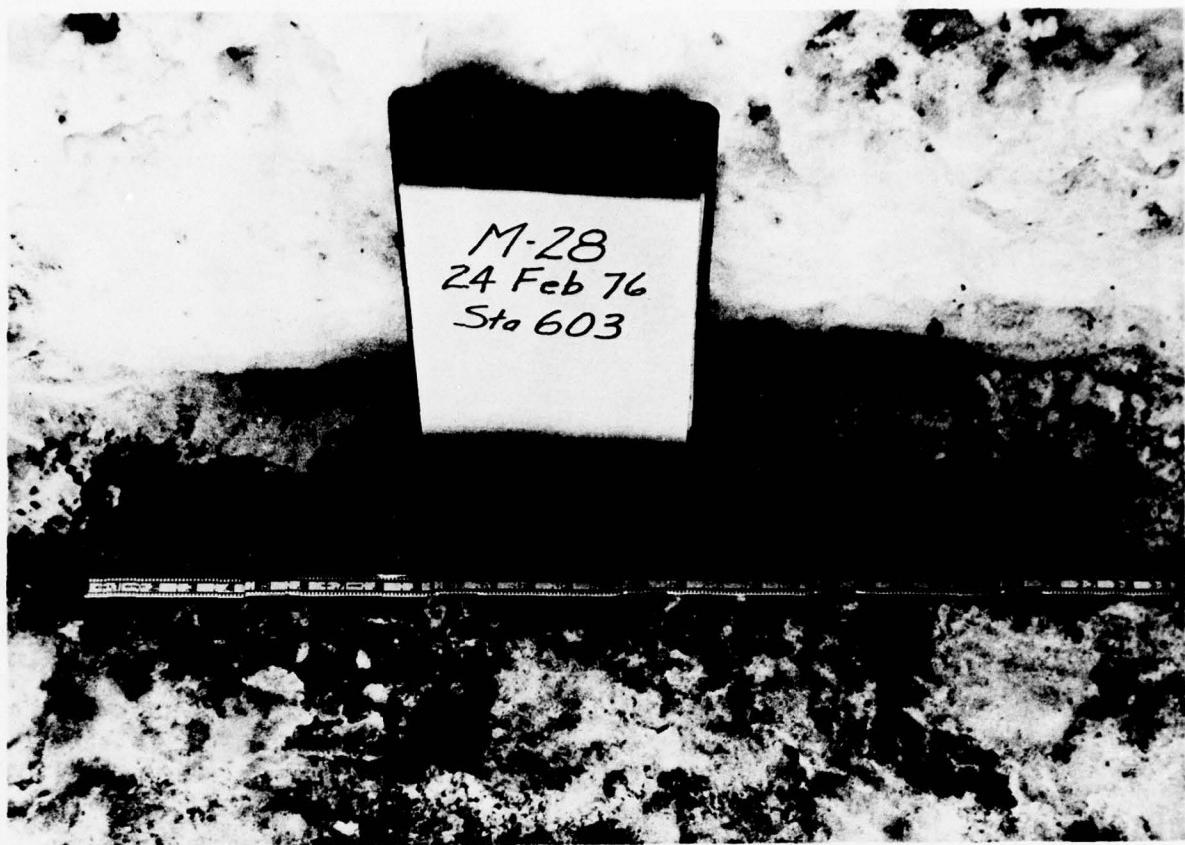
24. Alger County. State Road 28. Core samples like these were packed in snow and taken back to the laboratory cold-room. Here the in-situ dry density in pcf and the moisture content in percent were determined.

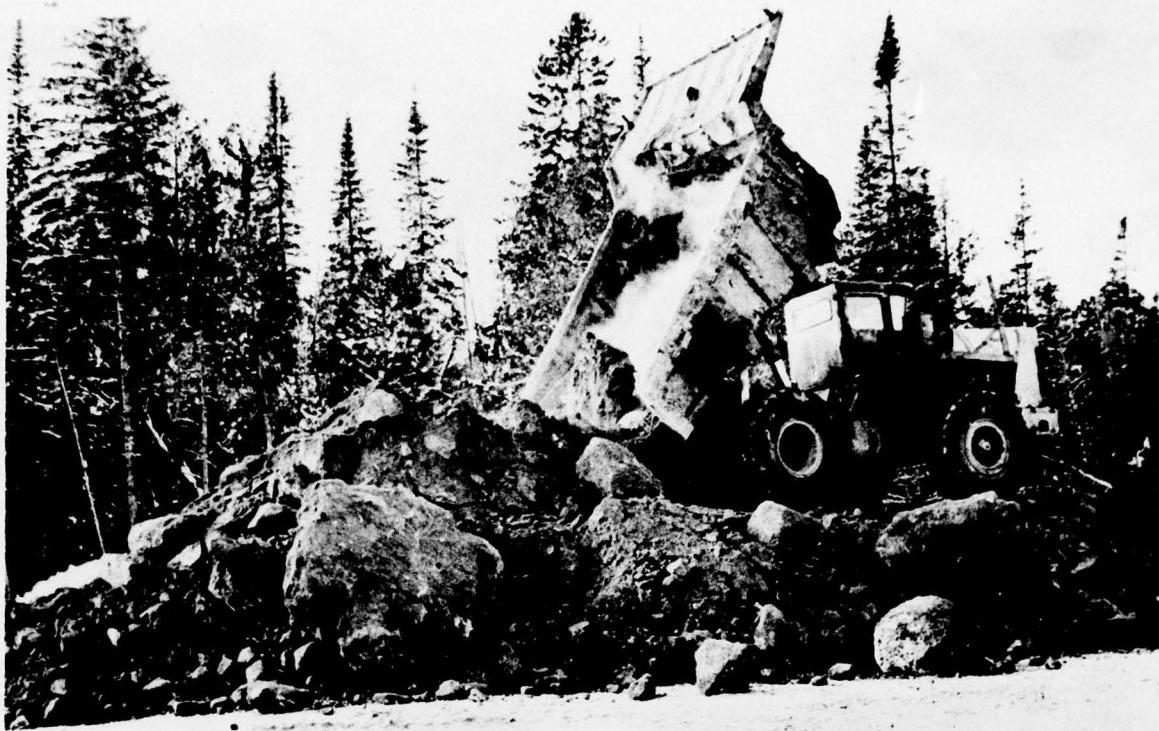
25. Alger County. State Road 28. Placing bouldery clayey soil in zone outside of structural core. Although this soil is not frozen, it was excavated, hauled and placed during the winter, and illustrates how frozen soil could be handled and utilized if necessary.

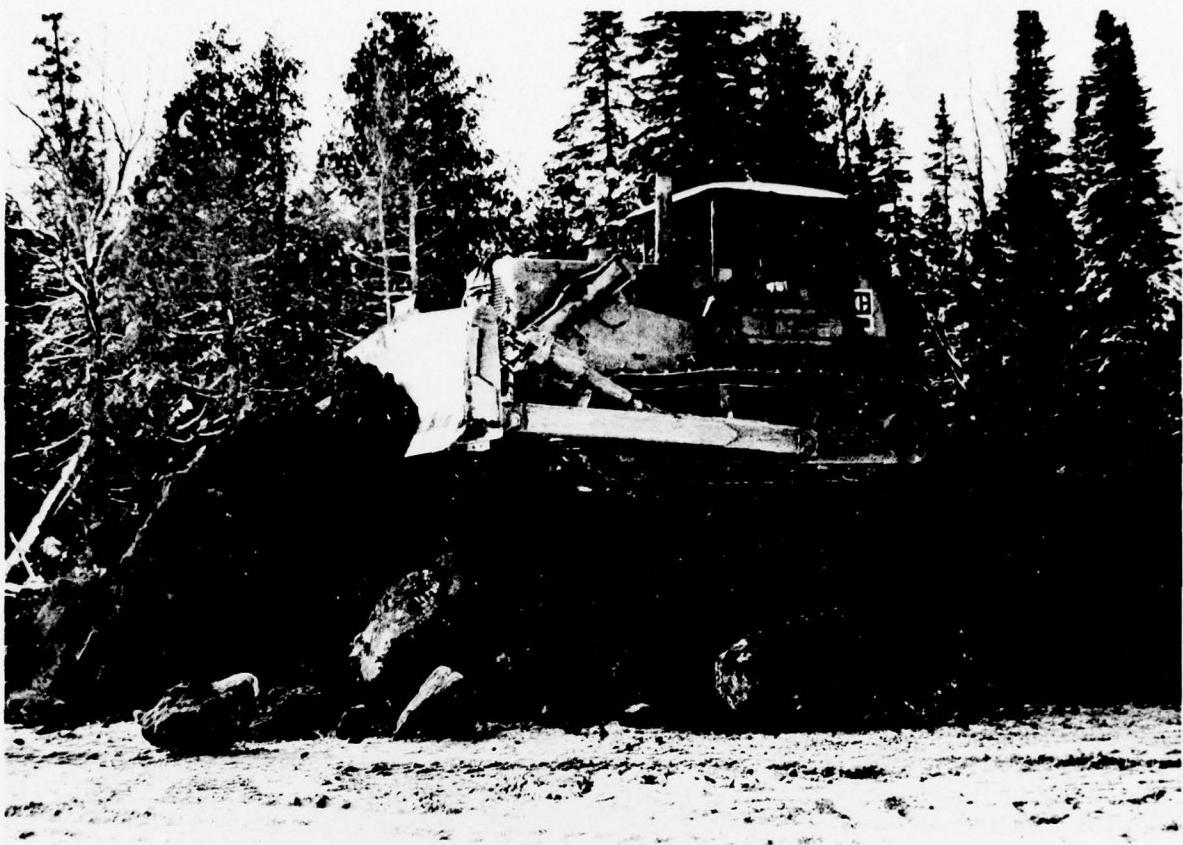
26. Alger County. State Road 28. Spreading bouldery clayey soil (see also Photo 25). Although this soil was not frozen during excavation and placement, the boulders can be considered to act like frozen soil chunks in the fill. Possibilities exist for the formation of large void spaces in the fill.

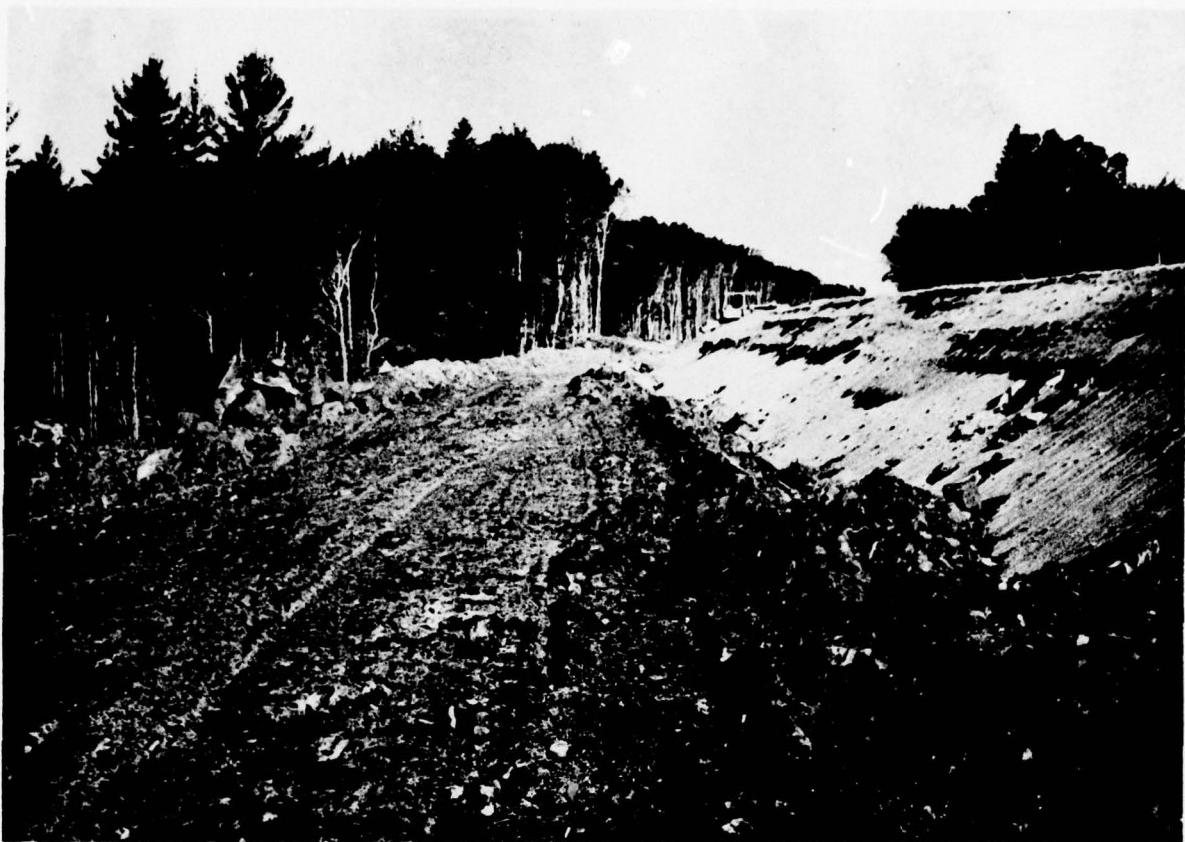
27. Alger County. State Road 28. This photo, taken in summer, illustrates the use of a structural core of sand in the embankment, flanked by less desirable soil in the slope zone. This bouldery clayey soil was placed unfrozen during the winter (see Photos 25 and 26), subsequently froze, and then was compacted and shaped after thawing. Photo taken in June 1976.

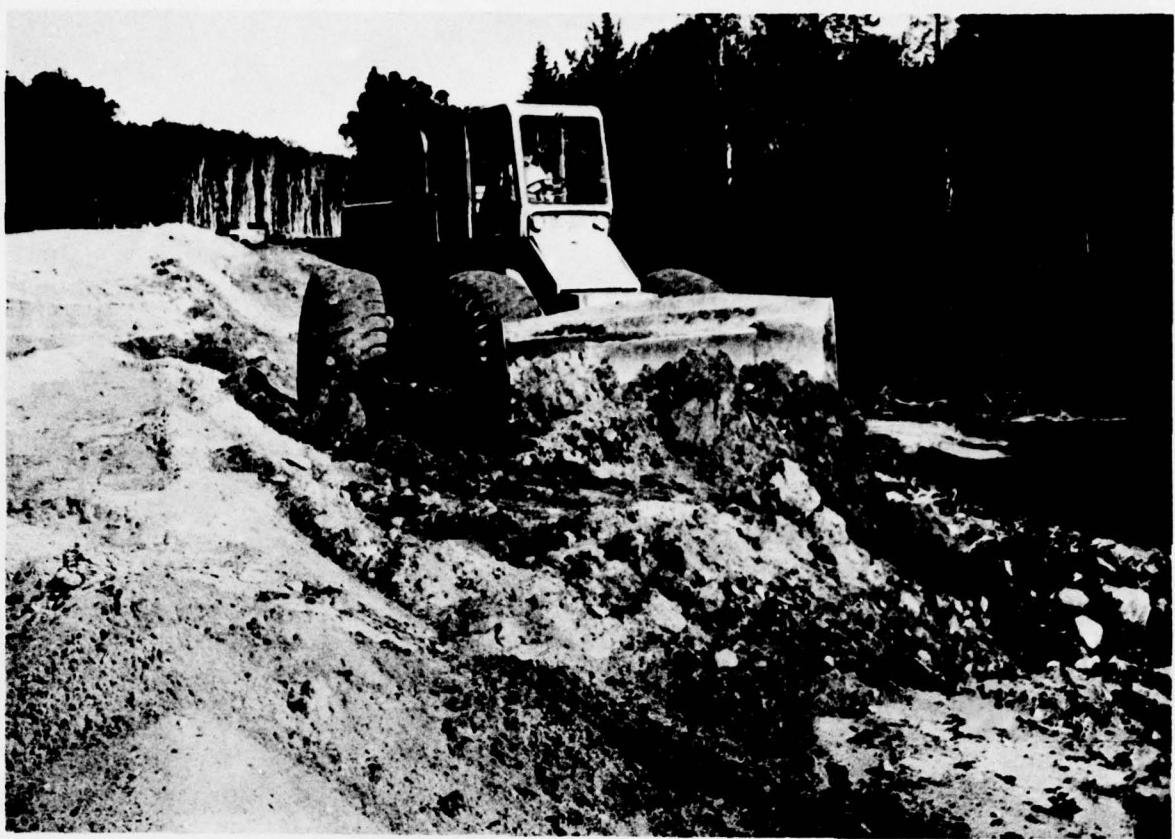
28. Alger County. State Road 28. Large rubber-tired dozer compacting soil in slope zone outside of structural core of sand. See also Photos 25, 26 and 27.
